# PAPER 622 - WEAR RESISTANT PROTECTION OF WOODEN POLES IN ADVERSE ENVIRONMENTS

Andreas Treu (Nibio)

Thomas Lindblad (WOPAS)

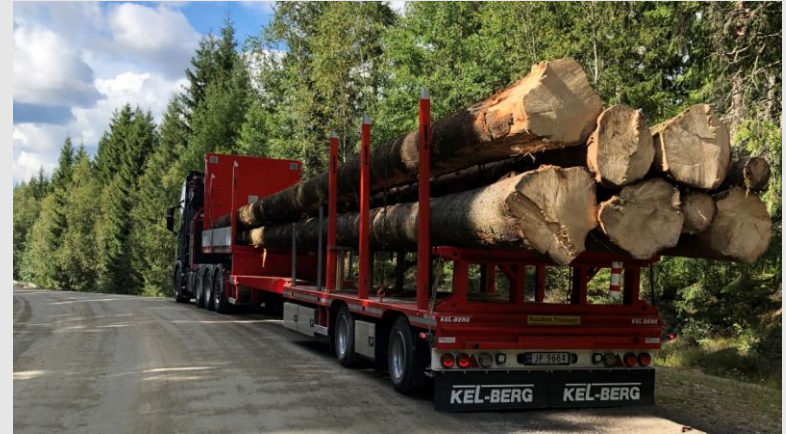
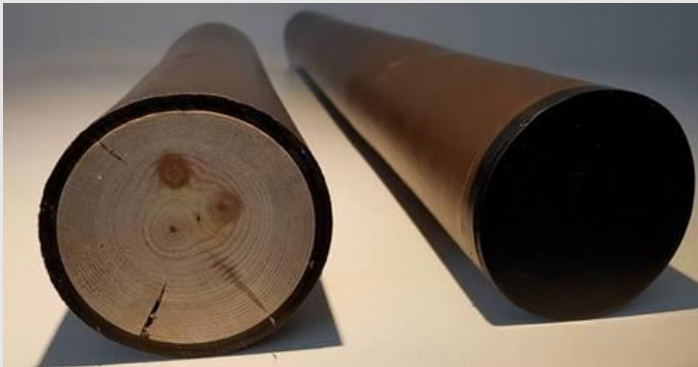
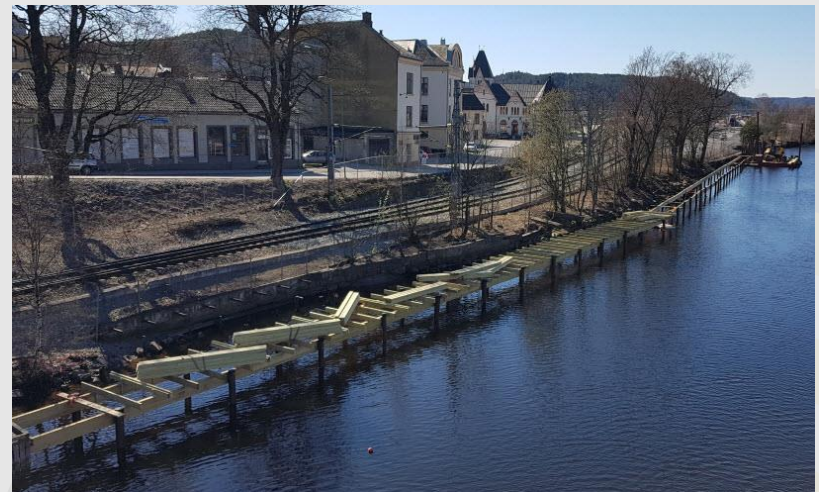
The picture shows a cross section and a PE welded cap. Lengths can be of 1-31 m, and  $\varnothing$  8-50 cm.

WOPAS uses such PE extrusion technology to wood which can be of different shape, square, cylindrical, or tapered.

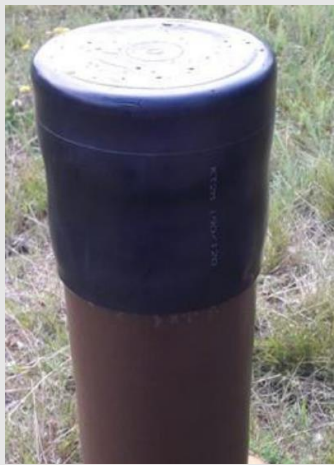
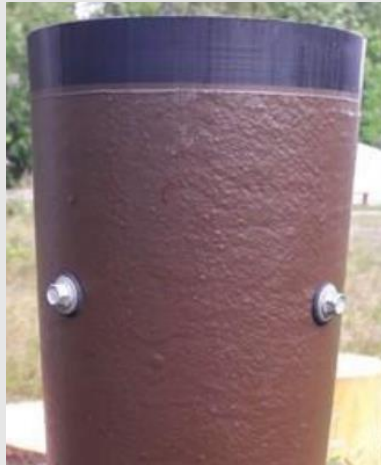
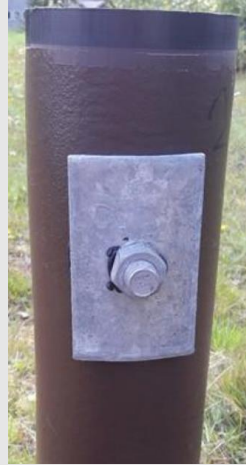
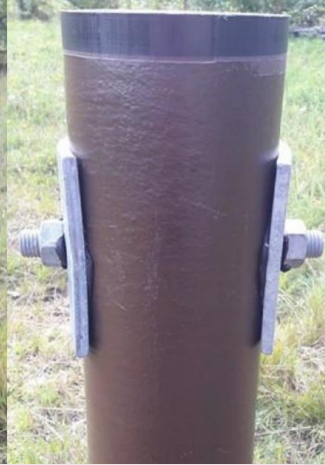
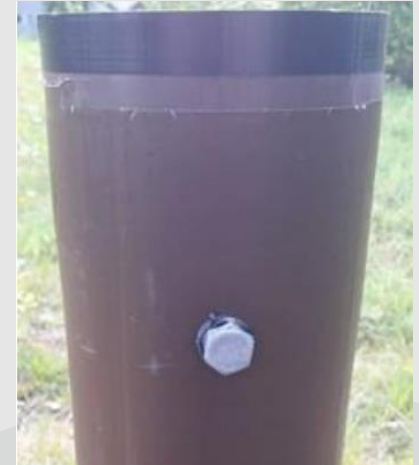
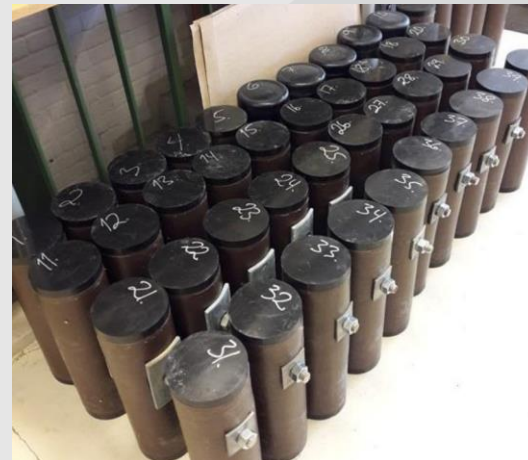
- A variety of bolts and fasteners was used, 5 pcs of each, and in addition reference test bodies without penetration as well as samples with deliberate damages or missing sealant.

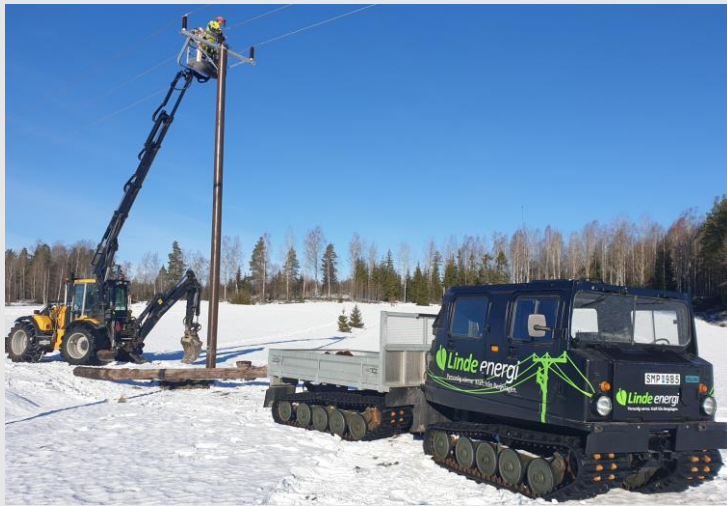
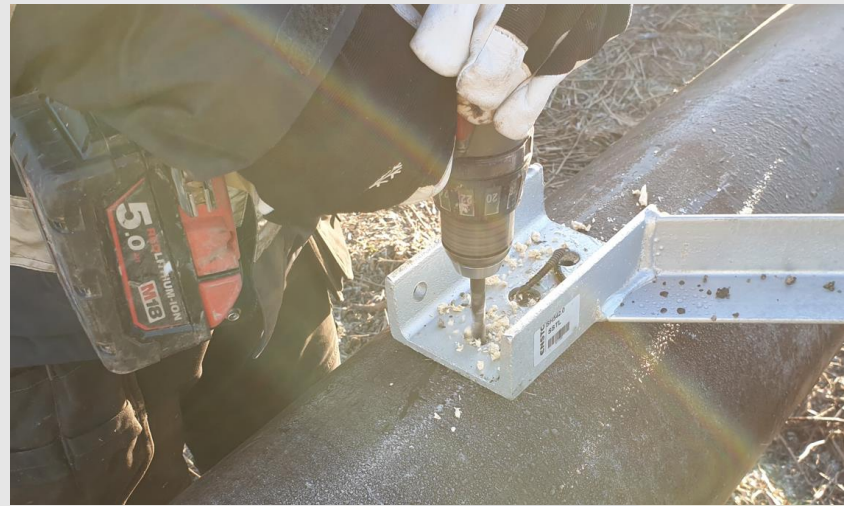
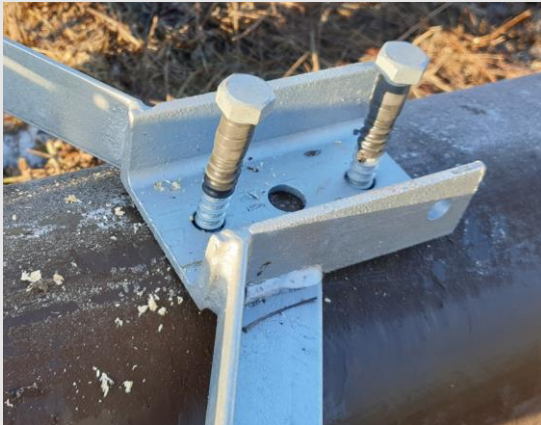
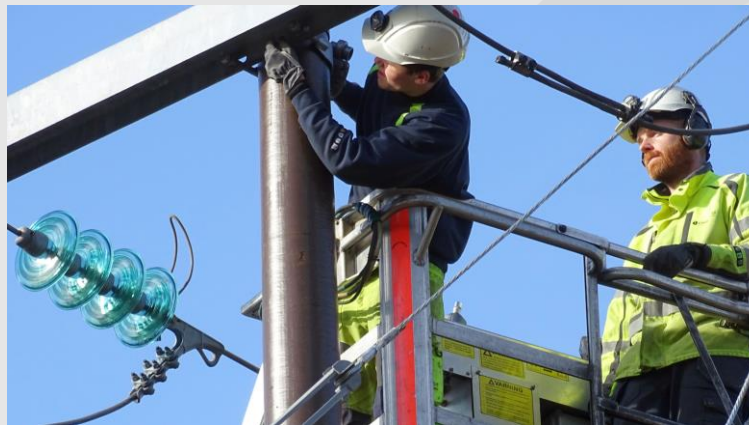
- A 40 kV overhead line with 108 WOPAS poles was installed early 2019 and finalized in May.
- The fitters used WOPAS recommended fasteners, i.e. pin bolts with curved washer and mastic, French bolts with mastic and building board screws with gasket.

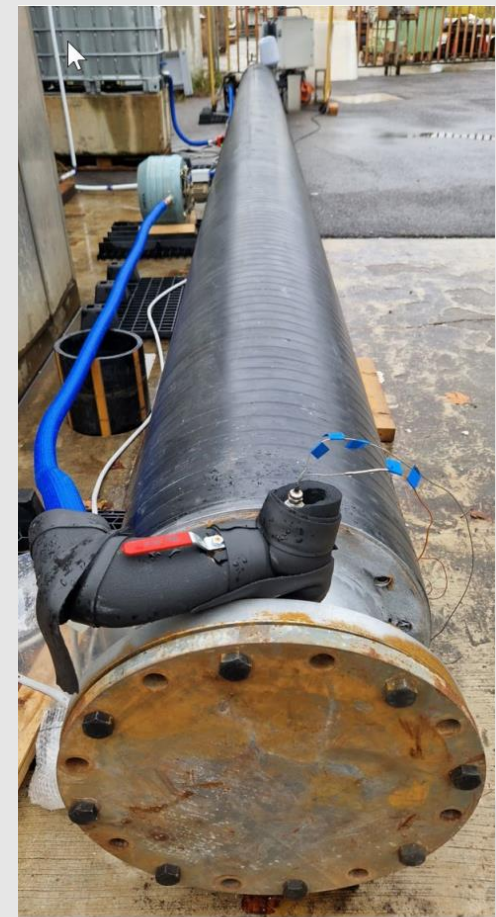
*Figure 7: Steel tube containing a WOPAS pole for age testing.*

- Pole sealed at the ends, was placed in a cylindrical chamber with circulating water.
- The water temperature was controlled and varied between 20 and 80 °C (figure 6).

- At the end of 1000 hours the pole was extracted from the steel tube and inspected for cracks to the PE and welded end caps.
- The pole was then tested with a bending test to compare any deviation to other non-aged WOPAS poles.

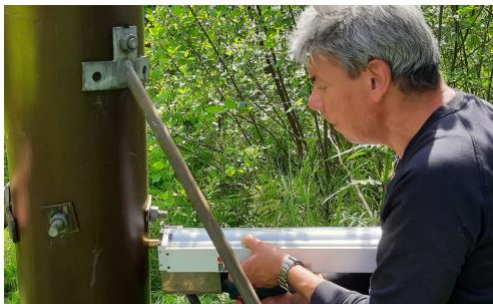
**Figure 5** Drilling measurement using a resistograph, close to pin bolt with curved washer and mastic.

- Of the 108 poles a selection of eight poles was installed in different environments, such as arable land, forest, swamp, rocky ground and gravel. Several methods were used for the survey, such as classical hammer sound surveying, non-destructive electronical moisture meter and drilling resistance measurement.
- The visual inspection showed no deviations. The moisture measurements demonstrated no elevated values of wood moisture content. The resistograph showed no unusual values, which could indicate deterioration of wood components.
- The hammer control noted two anomalous sounds, one behind a mark caused by the installation of the poles using excavator grab john and another at a random place. Both locations were examined with moisture measurement and resistograph.

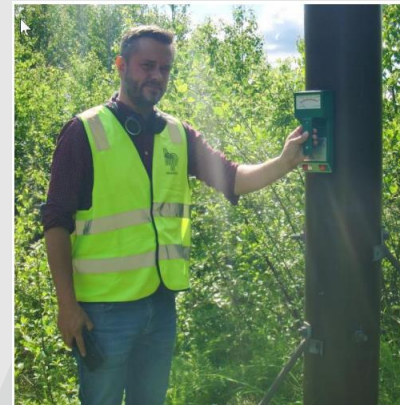
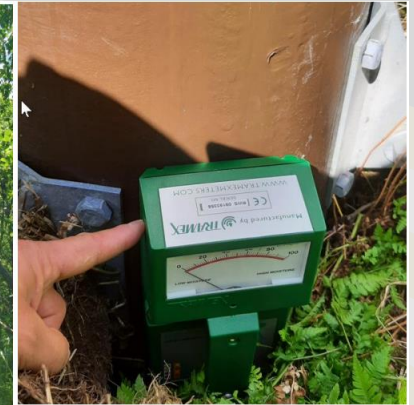
- After the aging test, the pole was tested for bending, impact (IK) and the PE was removed to measure the moisture level and for visual inspection of any coloured fluid.
- The moisture level was observed at two positions, as shown in figure 12, and the moisture level was 10,5-10,7%.
- It has been pointed out by CESI and Enel Grids that the specification and aging method have been defined by them for their test, and cannot be extrapolated.
